# Gas Insulated Switchgear (GIS) Building Concrete Cracks Causes, Testing and Repair Procedures

▲ By Saeed S. Alshahrani, Anwar K. Bloch, Abdullah S. Algrayan & Ziyad F. Alzamil

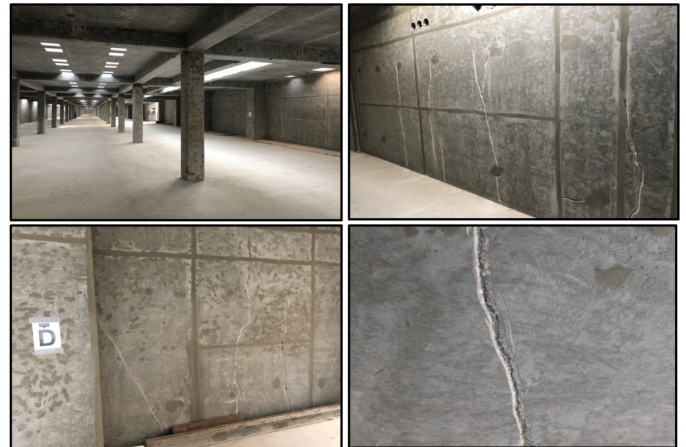
Figure 1: GIS Basement Floor

During construction of GIS Building, numerous vertical and diagonal cracks appeared in the basement concrete walls and roof slab after the removal of the formwork. In order to resolve these cracks, various tests were conducted to check and verify the nature of the cracks (structural/non-structural) by doing Root Cause Analysis (RCA) with repair procedures to fully rectify the cracks.

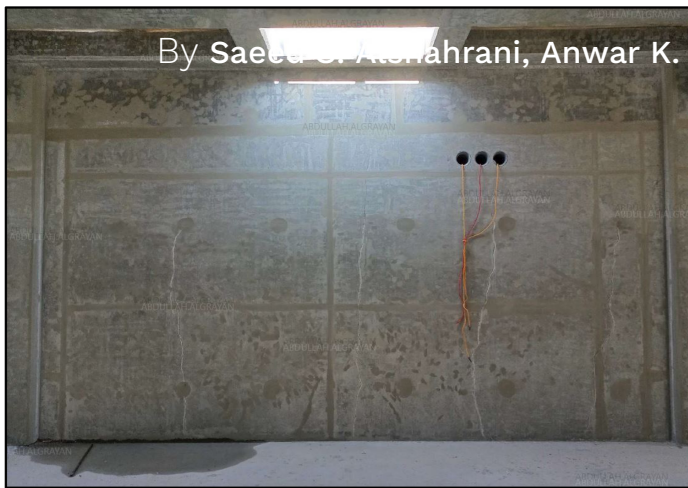
Figure 2: Cracks Pattern

- The cracks occurred in the upward direction from the lower foundation constraint surface of the basement wall, and were generated at a certain distance between the pillars (see Figure 2). Additionally, most of the crack widths observed by the crack gauge were 0.5 to 0.7 mm.

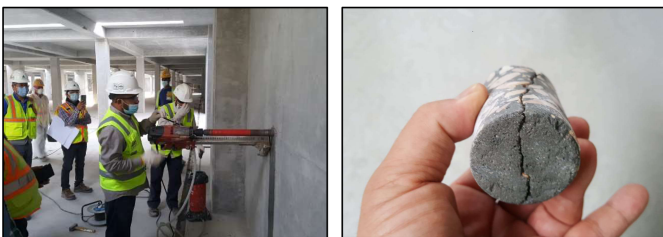
Figure 3: Core Sampling

- A core sample was collected to check the crack depth, and a maximum of 70 mm was checked to minimize damage to the reinforcing bars. (see Figure 3)

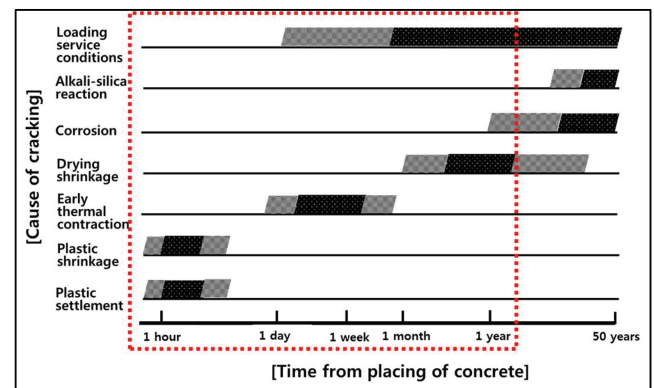
Figure 4: Causes of Cracking Against Time

- Figure 4 defines the causes of cracks over time. As the basement wall is a vertical structure, the possibility of cracking due to plastic settlement or plastic shrinkage that occur in the early stage of curing seems very low. Also, since the cross section of the wall is 300 mm, the possibility of cracking due to heat of hydration is also low. Therefore, the cause of cracks in the basement wall is considered to be caused by dry shrinkage or loading service condition when considering the pattern and timing.

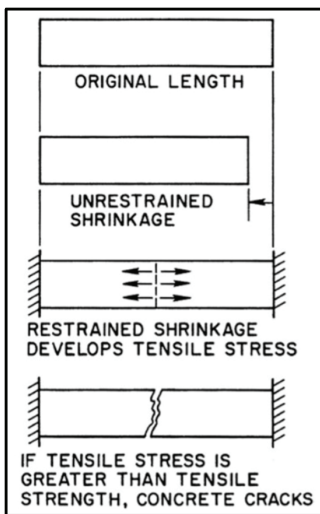
Figure 5: Concrete Cracking Due to Shrinkage

- Dry shrinkage cracks occur due to the volume change as a result of moisture losses. If the concrete is unrestrained, no shrinkage cracking occurs. However, the combination of shrinkage and sufficient restraint produces tensile stresses. When these stresses exceed the tensile strength of concrete, cracks occur over time.

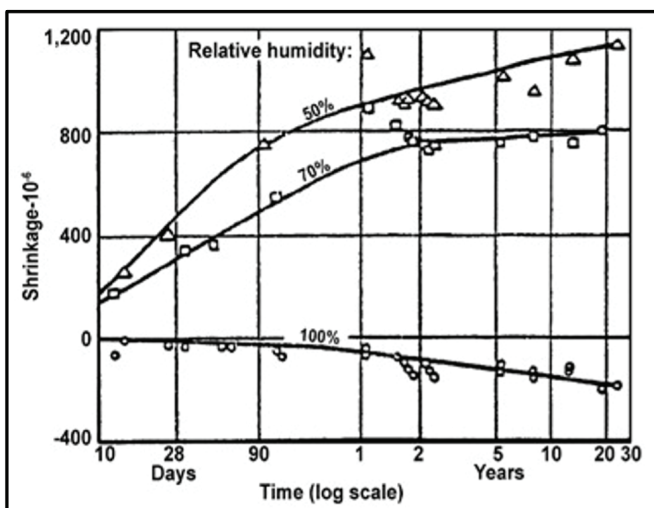
Figure 6: Effect Humidity on Shrinkage Against Time

According to ACI 224R-01, the lower the relative humidity, the greater the ultimate shrinkage and rate of shrinkage in Figure 6. Actually, since formwork removal, the relative humidity has dropped down up to about 10%. It can be estimated that the lower relative humidity has influence

on the additional crack propagation after dry shrinkage cracks.

of general dry shrinkage cracks. The range of crack width was inspected mainly with 0.6 mm wide, and sparsely with 0.7 mm wide. Because of low relative humidity and earth pressure due to the backfilling soil compaction, the cracks seem to be additionally propagated after dry shrinkage cracks were initiated.

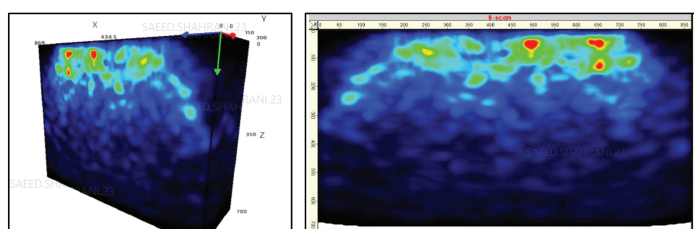
As summary of the tests result and according to the tests report, the average crack depth was 83 mm, and the quality of the concrete was mostly evaluated as sound.

Based on the test results, it was recommended to repair the cracks using epoxy grout injection method. In GIS basement, Nitomortar TC 2000 epoxy with CONBEX-TRA EP 10 was used. It is high strength epoxy resin grout. It shall provide good general chemical resistance, and a 7-day compressive strength of at least 93 N/mm<sup>2</sup>.

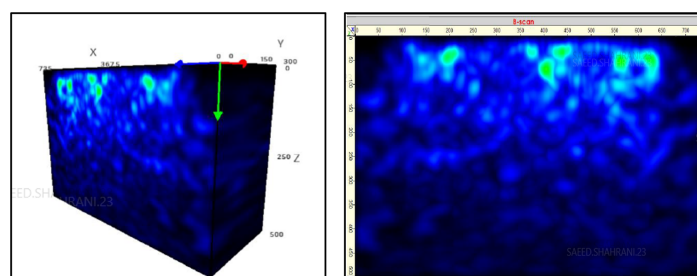
Figure 10: 3D MIRA Scanning Result for point 19 after repair

MIRA Tomography was used to inspect the internal quality of concrete to detect any internal voids, cracks or honeycombs after repairing. The test results for most of MIRA readings showed that the internal quality of the concrete is in good condition. Except testing point #3, in the beam and point #5 in the slab revealed some minor internal defects in the form of voids.
