Project
Management
Institute.
Kingdom of Saudi
Arabia

Enhancing Weld Integrity in Pipeline Projects: Overcoming NDT Limitations through Procedure Optimization

By: Maytham Sadah & Misfer Zahrani

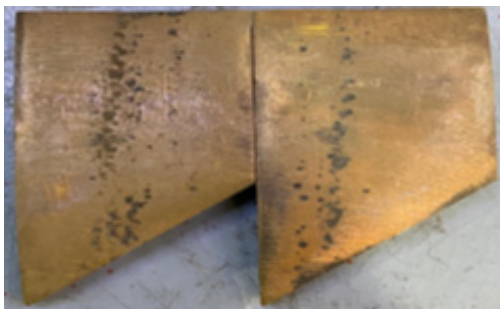
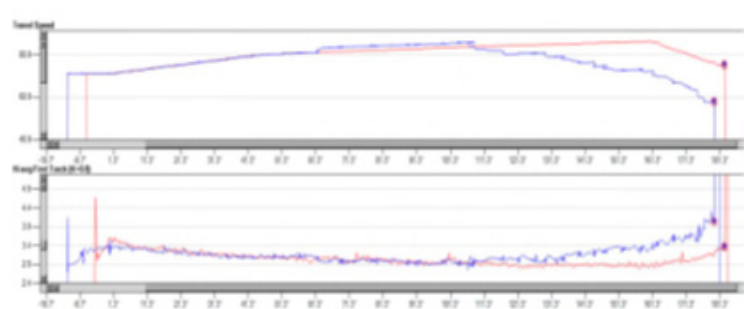
From the analysis above (Why-Why analysis)

1. Excessive high heat input resulting from low travel speed due to lack of boundaries for the required travel speed for the mechanized welding process within the WPS parameters.

As per pWPS only Oscillation and Travel Speed were allowed to be adjusted by the welder within the WPS range for Travel Speed. However, during the production welds, welders failed to maintain the boundaries for the required travel speed for the mechanized welding process within the WPS parameters. The welding operator unknowingly and unintentionally reduced the travel speed beyond the WPS ranges.

2. Failure to control copper shoe whenever signs of deterioration are detected.

3. Flaw of a quantifiable method of inspection for the Mechanized Welding Process, making emphasis in copper shoe control before and after welding of root and hot-passes.

4. Inadequate welding operator training could be one of the root-causes that welding operators were reducing the TS.

5. One of the causes for the failure to identify the defect right after the welding was that the approved AUT procedure did not consider a transverse channel to detect transverse cracks.

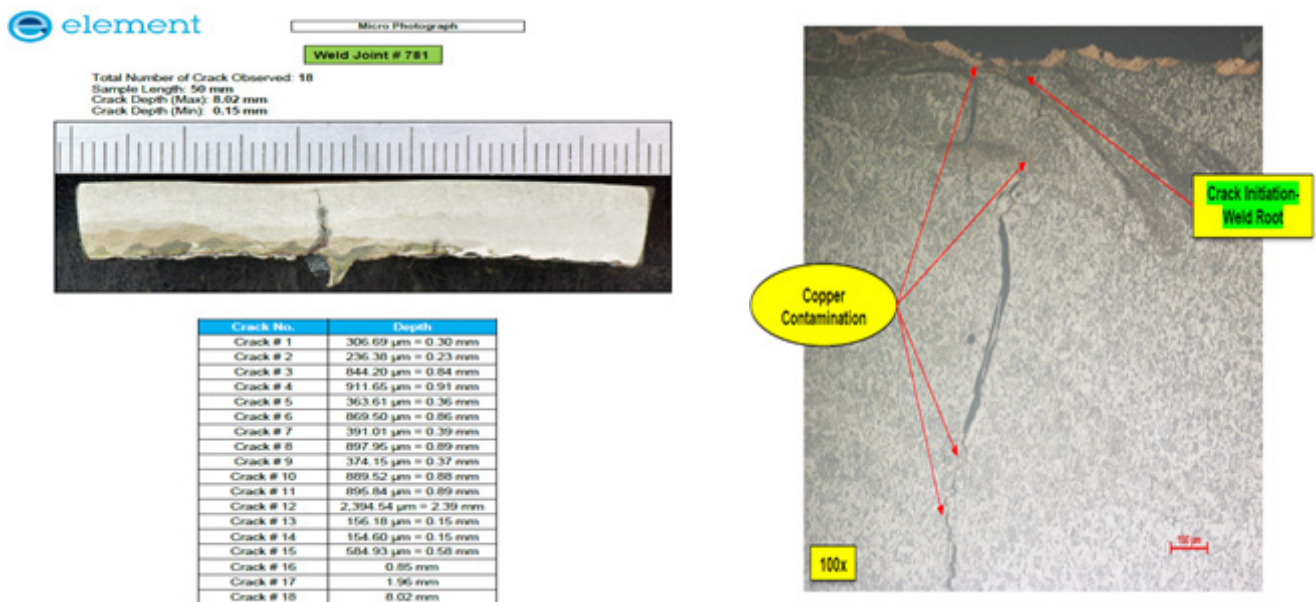
Micrographs showed crack initiation along the fusion boundary, with clear indications of copper segregation. These were not captured in RT due to its inherent resolution limitations in detecting micro-level discontinuities, especially transverse to the beam path.

Picture C: list of multiple micro cracks in on location

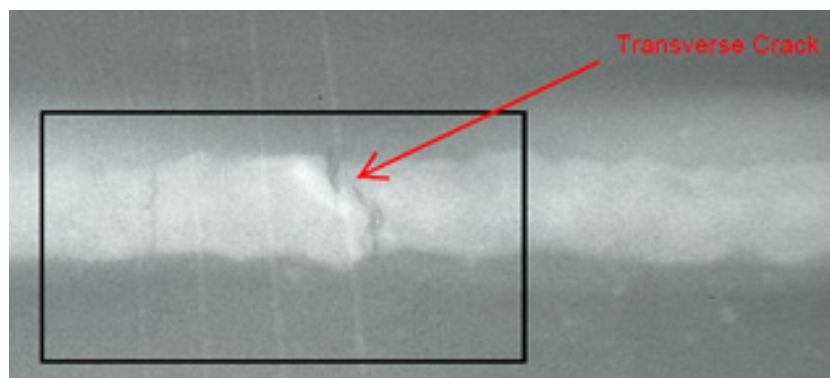
Following RT scans on selected welds, transverse cracks were discovered in two joints. These defects were not detected by the original AUT procedure, raising concerns about the method's sensitivity. RT film review revealed the presence of a single major crack, while further metallurgical sampling uncovered 18 microcracks in the same region, significantly exceeding initial estimates.

Picture E: RT film showing the defect

The two defective joints were removed. Surrounding joints (10 preceding and 10 succeeding) were re-inspected using RT. Thirteen additional cracked joints were identified, totaling 15, all of which were cut out and rewelded.
