Restoration of Product Fractionator at Riyadh Refinery

This technical paper describes problems/issues, challenges faced, steps followed and actions taken by the restoration team for the product fractionator column (R215-V18) restoration work at Riyadh Refinery.

The restoration was needed due to the fire incident on 19 March 2021 in localized areas within Riyadh Refinery, in the hydrocracker unit (HCU), resulting in damage to multiple equipment.

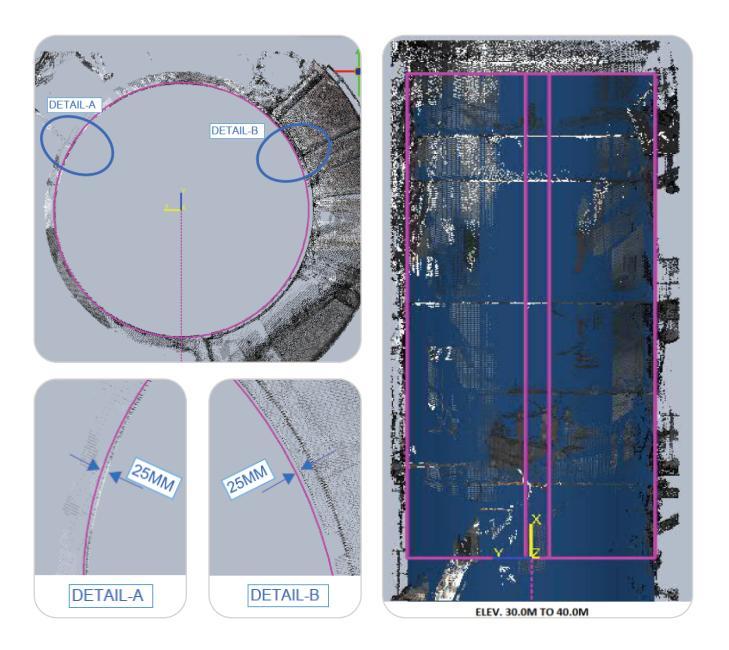
• The design consultant mobilized their 3D laser scanning team and performed the 3D scan of the complete area, including the fractionator column. This provided an initial indication of column shell distortion as a result of the fire damage (Figure 1).

Figure 1. Laser scanning images elevation and plan views.

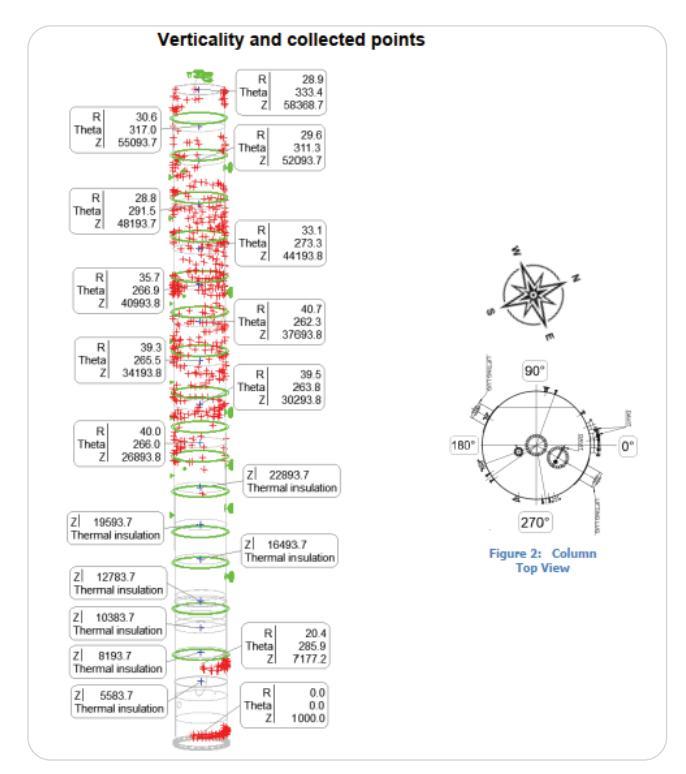
• ZPEC through their laser subcontractor verified the verticality, circularity and displacement of the column and recorded the readings at different elevations (Figures 2 and 3).

Figure 2. Column verticality overview

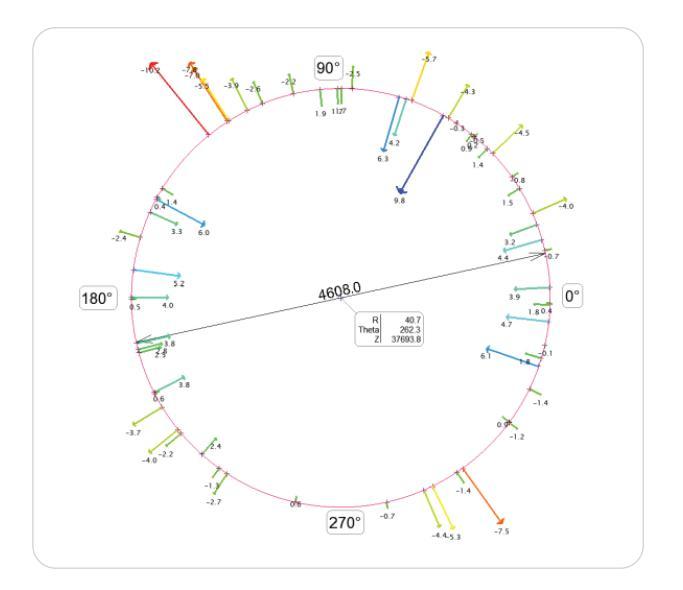
Figure 3. Circularity & displacement of the shell @ EL +37694 mm

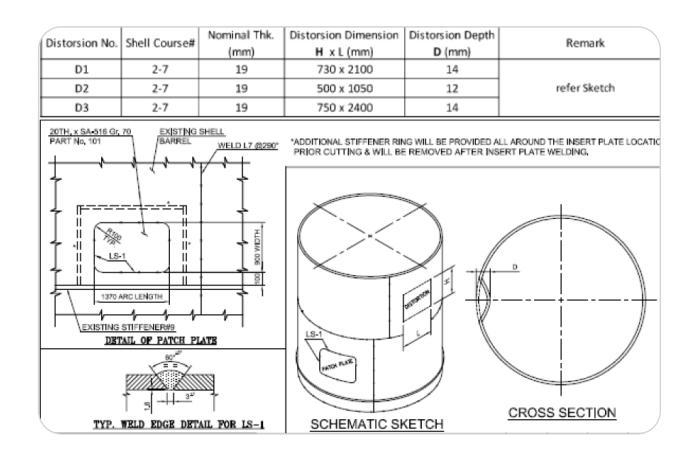
• ZPEC performed the FFS analysis in accordance with ASME FFS-1 and submitted the report for CSD review and approval. Specific focus was on the major shell imperfections identified in the final assessment report (Figure 4).

Figure 4. Major shell Imperfections observed in three locations.

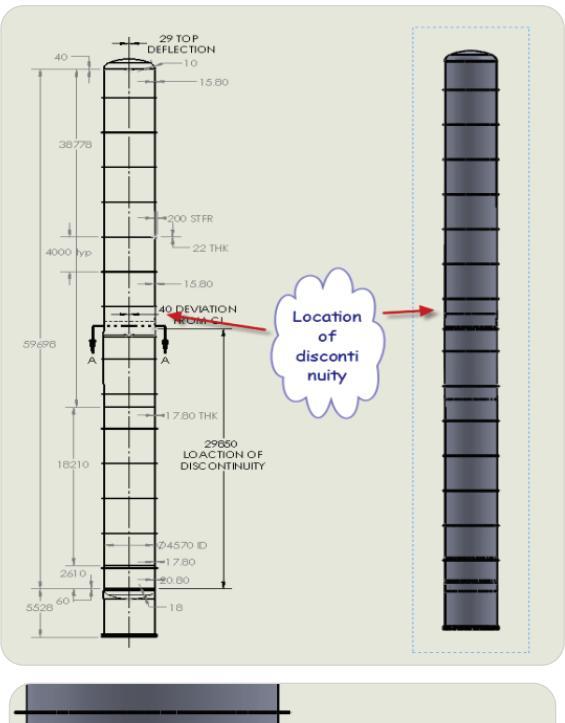
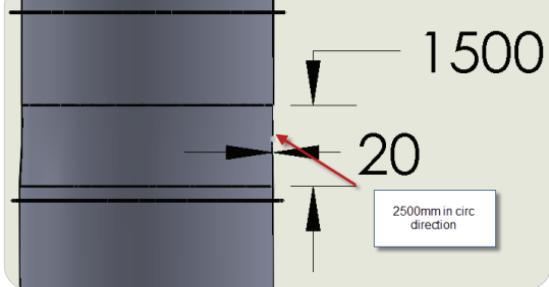
• ZPEC performed the FEA analysis of the whole column as part of FFS analysis considering discontinuity at the major imperfections (Figure 5). The FEA report was reviewed by CSD and the design consultant. • The FEA report concluded that the equipment was safe for re-use and continuous operation.

Figure 5. Distorted cylindrical section

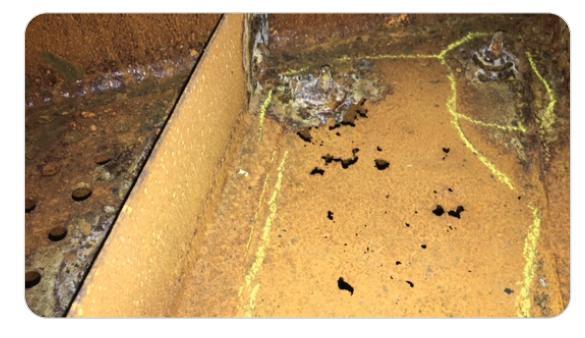
• Anabeeb, a subcontractor to the construction contractor was mobilized to perform the inspection of all internals. Anabeeb identified 16 trays, two chimney trays and two seal pans as fully damaged, which required replacement. Some trays had partial damage due to the fire incident and other trays had corrosion issues as shown in Figure 6.

Figure 6. Sample corroded internal parts

• Anabeeb installed all the internals including the new replaced trays (16), chimney trays (two) and seal pans (two). Some parts of the partial damaged tray were salvaged and installed on other damaged trays to save time and cost.

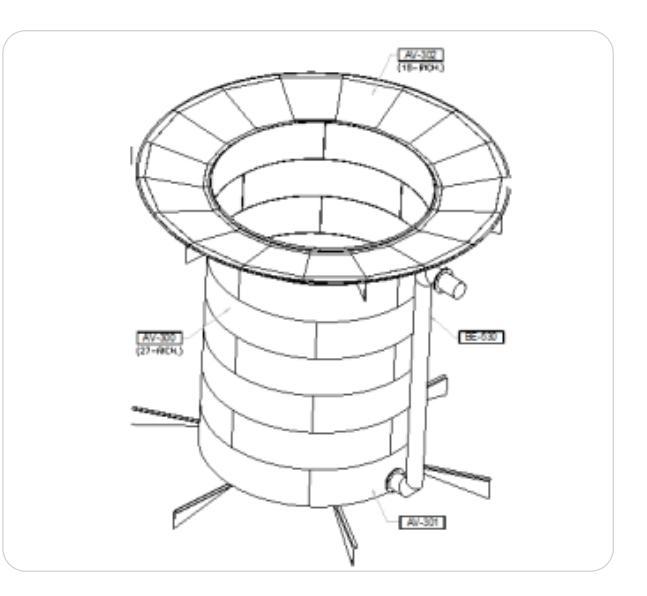
• The construction contractor also demolished the stripping section sleeve at the bottom of the column as result of corrosion issues.

Figure 7. 3D View stripped section sleeve

• The stripping section sleeve at the bottom of the column was replaced with a new improved design and with material upgraded to SS 410S from carbon steel (Figure 7).
