Project  
Management  
Institute.  
Kingdom of Saudi  
Arabia

# HPRT Paper

This paper explores the implementation of HPRTs in one of Saudi Aramco Mega Project, detailing the design, manufacturing and testing phases. It discusses the challenges encountered during development, including technical complexities, material selection and system integration, as well as the strategies used to overcome them. Additionally, the expected energy savings and economic benefits derived from HPRT implementation are analyzed, highlighting its long-term impact on sustainability and cost reduction. Furthermore, the different types of HPRTs available in the market and the rationale behind our selection are presented

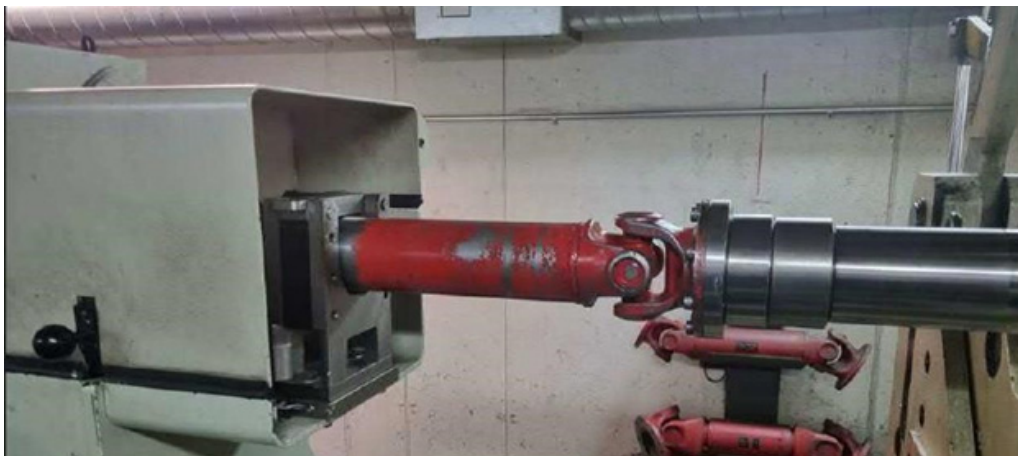
A dummy balancing hub—matching the weight of the motor-side hub of the customer coupling— was installed on the rotor D-end for the purpose of rotor balancing. After balancing, this dummy hub was removed and replaced with the actual customer coupling to verify the combined balancing state.

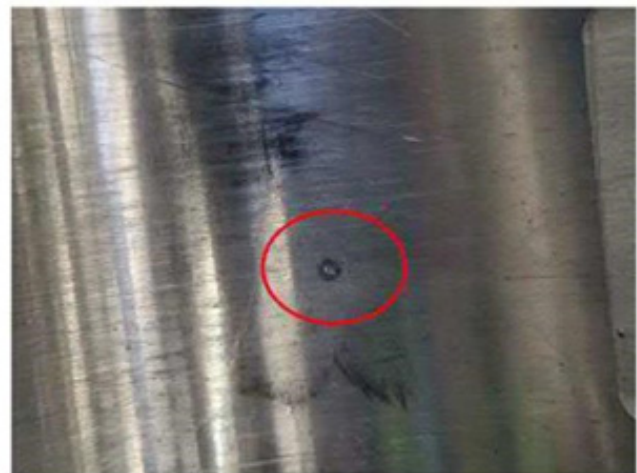
### 5.1.5 BEARING SHELL DENT:

During inspection, a small dent was observed on the bottom half of the NDE (non-drive end) bearing shell. This dent was likely caused by a loose particle trapped between the bearing journal and the shell during motor assembly. Given that the bearing shell is made from softer white-metal compared to the shaft, it sustained damage while the shaft remained unaffected. It was concluded that this particle had not been properly removed during cleaning prior to assembly.

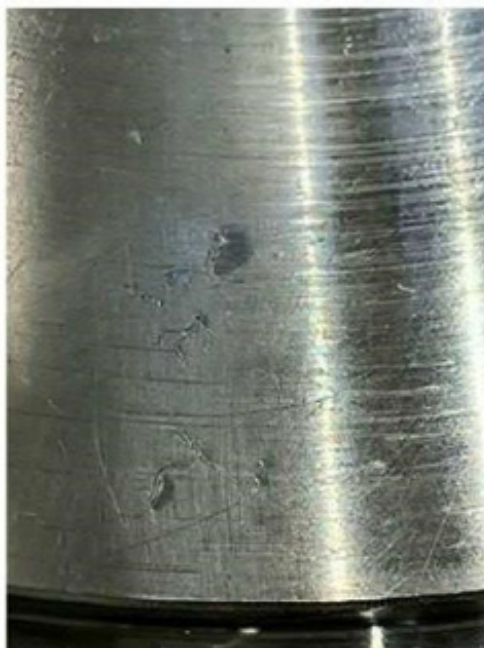
### 5.1.6 DENTS ON D-END BEARING SHELL SURFACE:

Dents were observed on the surface of the lower bearing shell at the drive end (Dend). While it is a typical feature for sleeve bearings to exhibit slight scratches or marks during regular motor use, in this instance, the D-end shell showed abnormal dents on the bearing's sliding surface. These irregularities exceeded the expected wear patterns and required further inspection to ensure continued reliability and operational safety.
