# Gas Insulated Switchgear (GIS) Building Concrete Cracks Causes, Testing and Repair Procedures

▲ By Saeed S. Alshahrani, Anwar K. Bloch, Abdullah S. Algrayan & Ziyad F. Alzamil

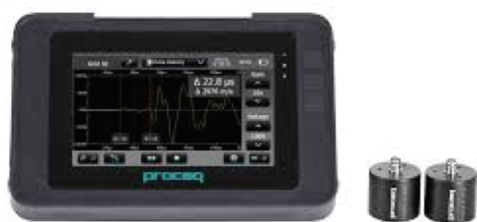
Figure 7: Ultrasonic scanning apparatus

Ultrasonic inspection gives an indication about concrete uniformity, quality, internal discontinuities concrete, and crack depth in concrete. The Ultrasonic Pulse velocity tests was performed according to ASTM C597.

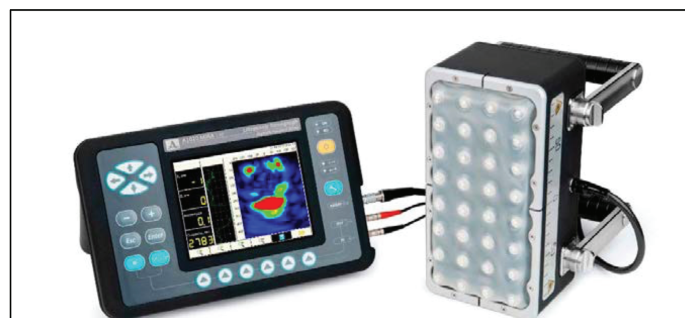
Figure 8: Ultrasonic Pulse Echo Scanning -MIRA

The Ultrasonic echo technology is excellent for detecting internal defects inside concrete in the forms of cracks, voids, honeycombs. The transmission range of pulse instruments depends on the quality of the concrete and the amount of reinforcement steel and it may reach up to 1.2m as an effective depth in solid concrete.

any internal voids, cracks or honeycombs. The test results for most MIRA readings showed that the internal quality of the concrete is in good condition. However, some test results revealed major internal defects in the form of internal voids and cracks. The summary of all results from tested concrete beams is summarized in Table 3. Also, some figures show the ultrasonic echo images for some point.
